RADC-TR-81-180

RADC-TR-81-180
Final Technical Report
July 1981

FAILURE MECHANISM STUDY OF GaAs TECHNOLOGY

Hughes Aircraft Company

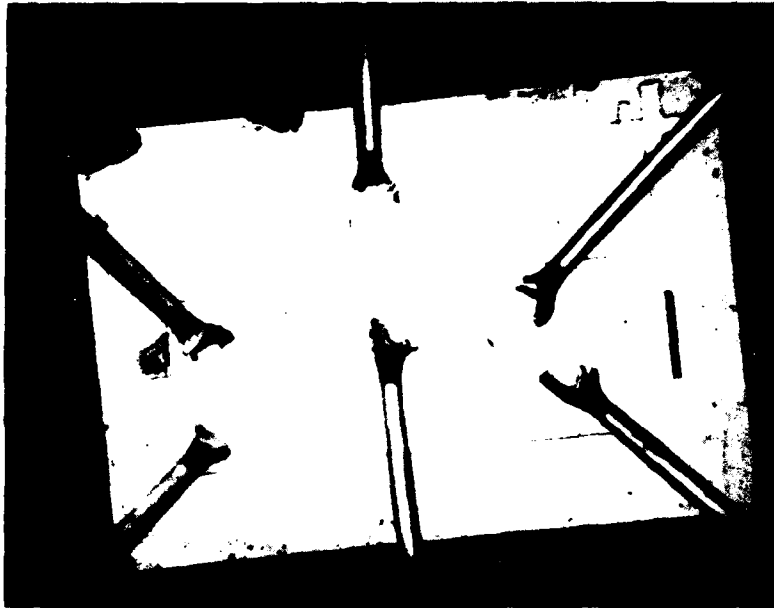
Figure 3-2 Type P-5 chip, showing smeared wire bonds required to obtain adhesion.

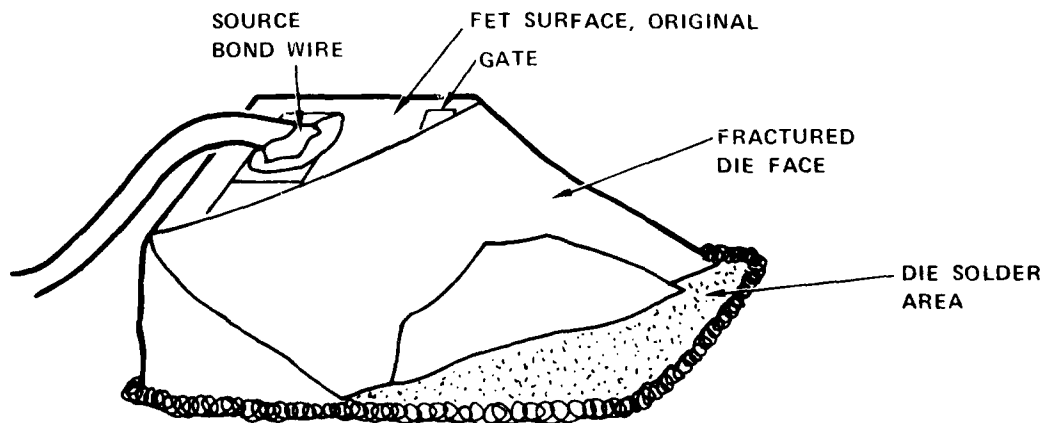
We hypothesize that the die was not completely wetted to the header solder and likely was cantilevered on one edge, the edge which is still attached. The test vibration probably caused the fracture. For the population of all devices tested, this represents 1 failure in 15. It should also be noted that both R-51 devices failed the hermeticity test following the random vibration test. The fractured die failure is probably due to a quality control problem in die attach rather than indicating anything fundamental with regard to the GaAs FET. On the other hand, one might observe that, because of the more brittle nature of GaAs, the FETs may be less tolerant of insecure die mounting than silicon dice would be.

Figure 3-5 Type R-51, #1, which failed during the random vibration test. (a) SEM photograph of fractured die, 600X. (b) Sketch identifying areas of interest.

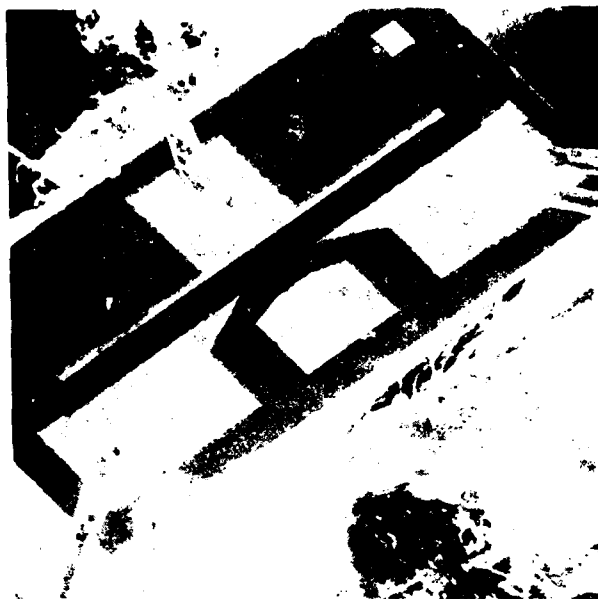
Figure 3-19 (a) SEM photograph of the failed Type H-11, No. 183 FET at 150X; (b) 6000X view of the gate failure site.

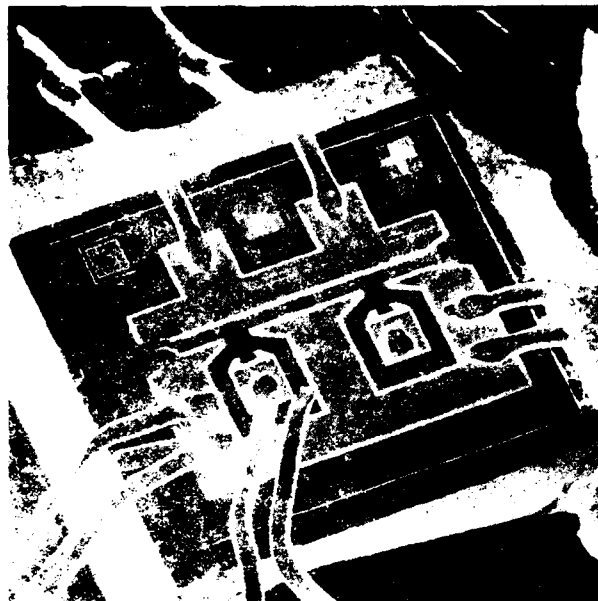
Figure 3-21 (a) SEM photograph of failed Type N-3, No. 8 FET at 160X; (b) Nodules on the gate stripe. 12,000X.

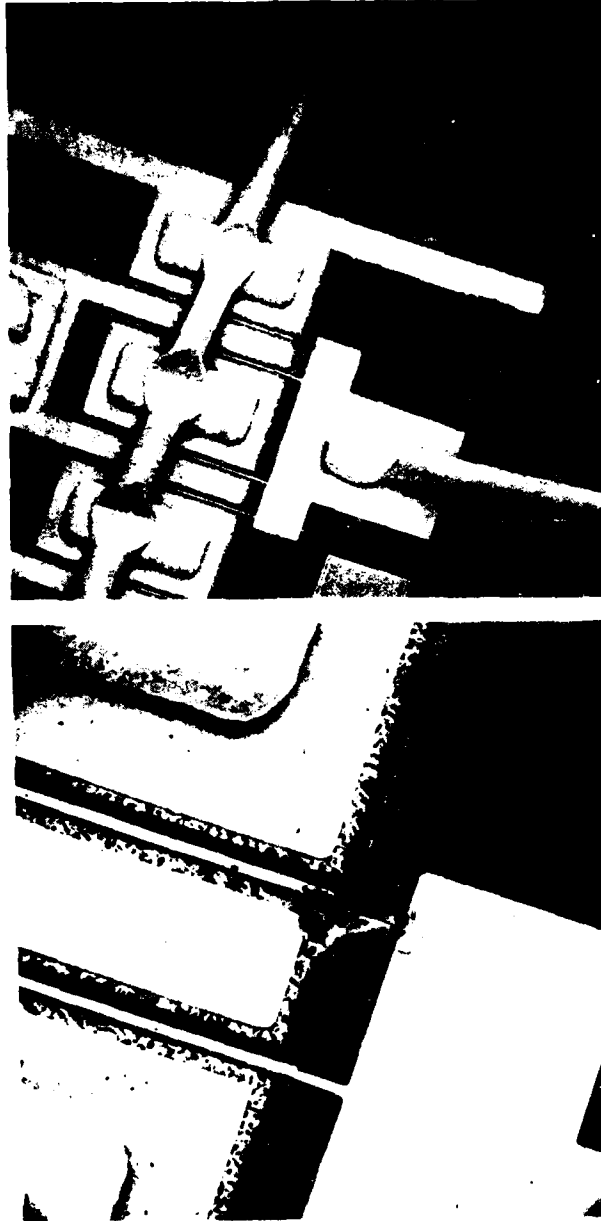
Figure 4-1 Type T-500/8, #1, after
maximum V_{DS} , $V_G = 0$;
electrical stress test.
SEM at 200X, 1000X.

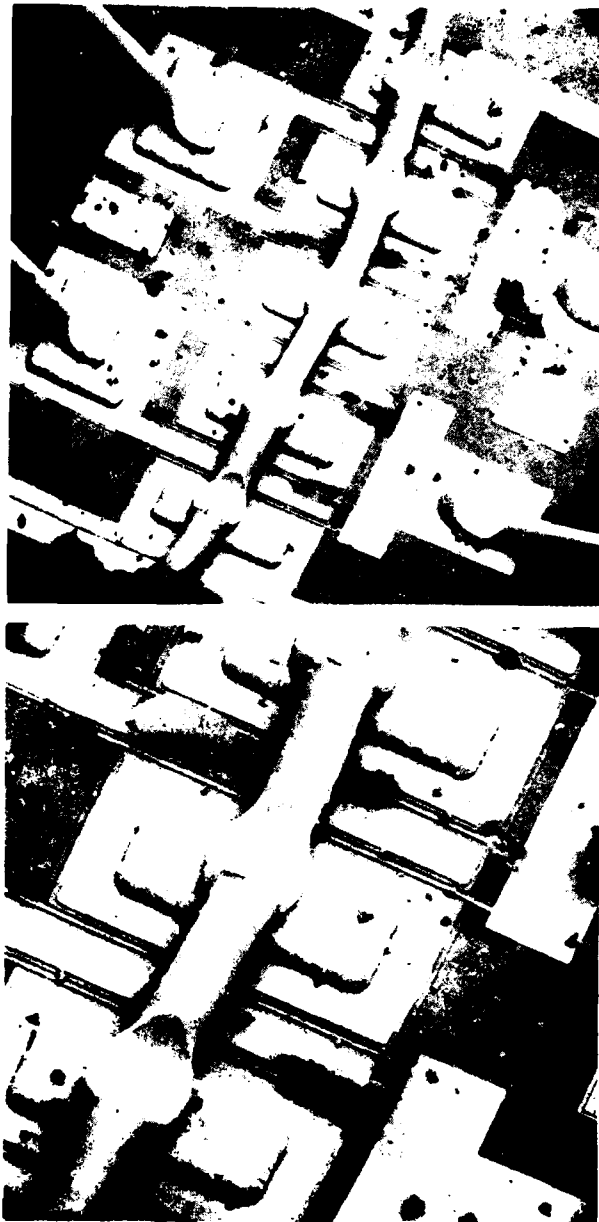
Figure 4-2 Type T-500/8, #2, after
maximum V_{DS} , $V_G = 0$;
electrical stress test.
SEM at 200X, 400X.

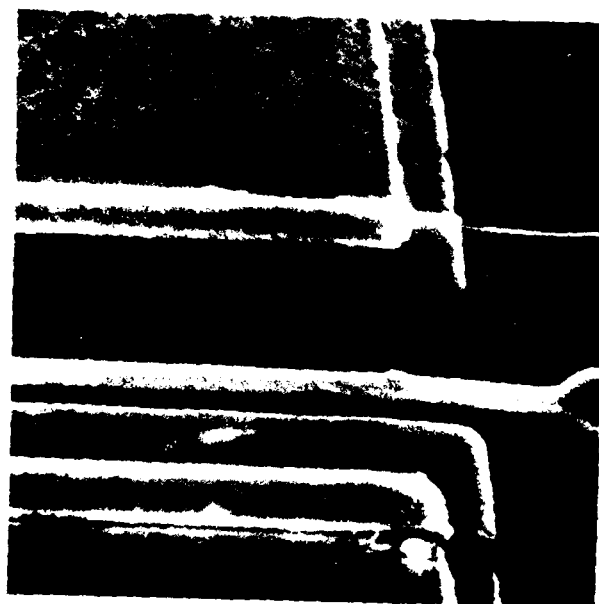
Figure 4-3 Type D-250/6, FET from Test A. (a) 200X, note cracked die. (b) 4000X, note black spots.

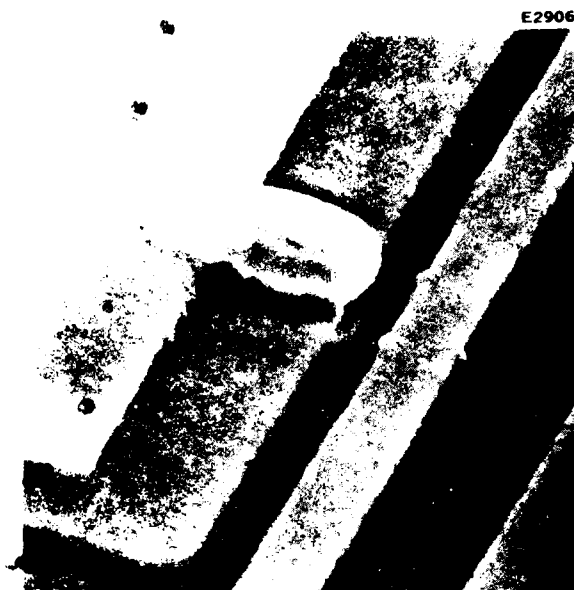
Figure 4-18 SEM photographs of Type D-250/6 #29 FET.
 (a) Bubble in glass passivation layer (8400X);
 (b) Piece missing from glass passivation layer (8940X).

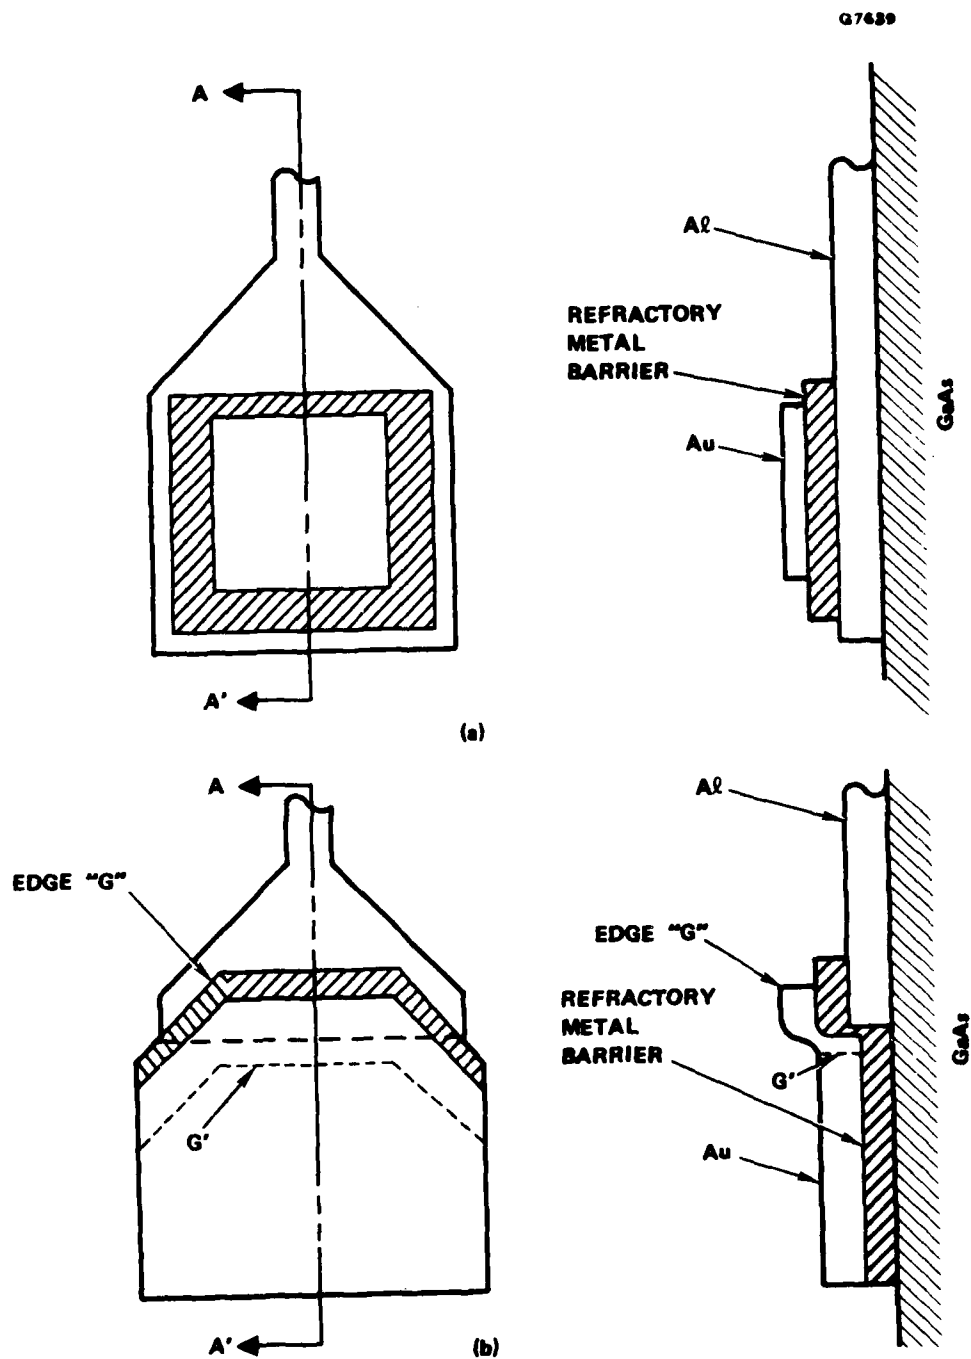
However, inspection of Figure 5-3(b) reveals other possible defects. As drawn, the figure shows Au overlaying the Al and climbing over its edge. The refractory is thin at this point and subject to the usual cracks and defects that result from applying a thin

Figure 5-3 Gate connector designs, gold-aluminum. (a) Gold overlays Al in band area. (b) Gold does not overlay Al in band area. See text for details.

metallization layer over an abrupt step. An alternative is to remove the gold edge back to the point labeled "Edge G'," so that the Au cannot possibly penetrate the refractory to the aluminum.

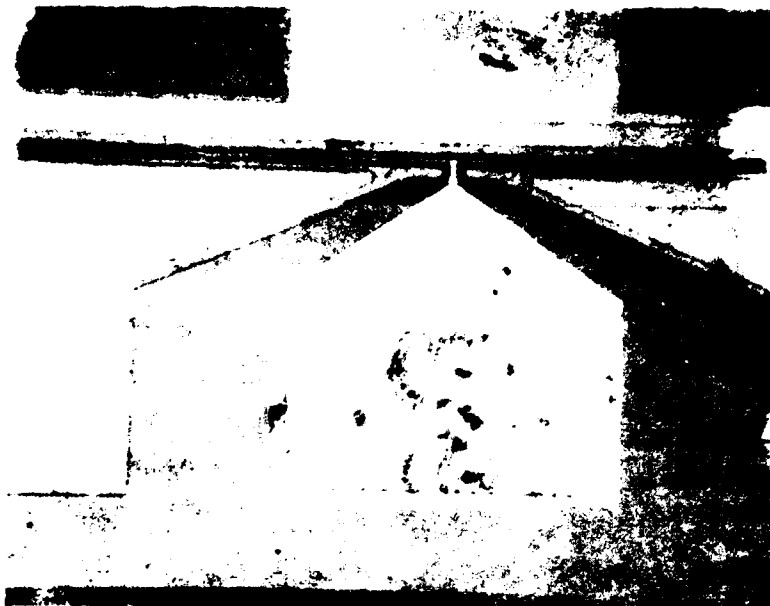
Figure 5-9 Type H-1 FET, sample E. (a) As received condition. 500X. (b) After 312 hours at 260°C. Note mottled source and drain areas. 200X.

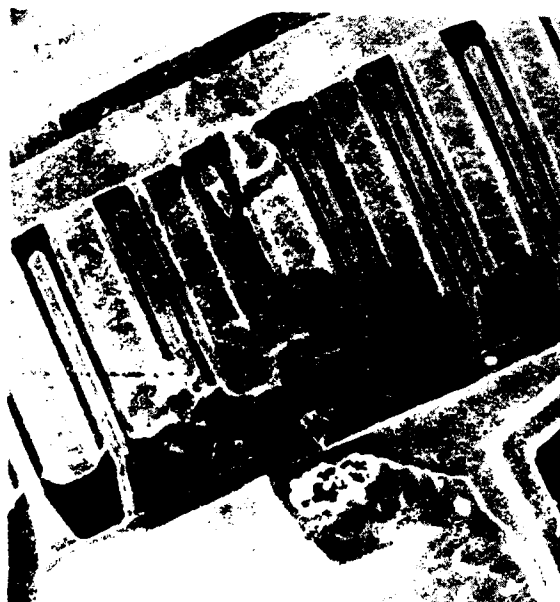
Figure A-1 Type A-51 #12 FET. Note
two failure sites. (a) 160X.
(b) 1700X.

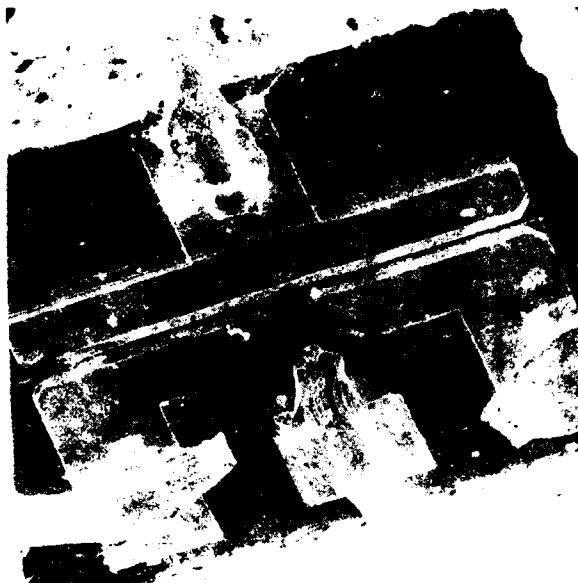
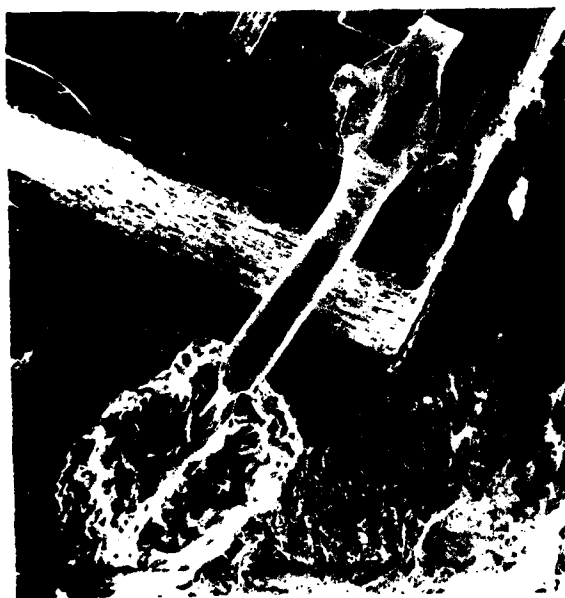
The only source failure in the medium temperature tests was of a Type R-51 FET, shown in Figure A-10. The now-familiar corrosion of the source lead depicted in Figure 3-4 can be observed in Figure A-10. It is unfortunate that the shipment of Type R-51 FETs that we received characteristically exhibited the source lead corrosion problem. Manufacturer R is a highly competent firm with an enviable record of superior work, and these Type R-51 FETs are simply not representative of his products.

Figure A-10 Type R-51 #3 FET that had a high resistance source. (a) 240X.
(b) Corroded source lead. 240X.

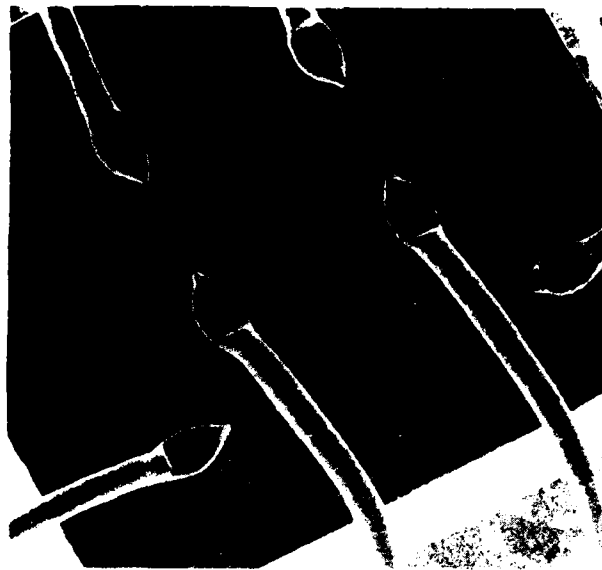
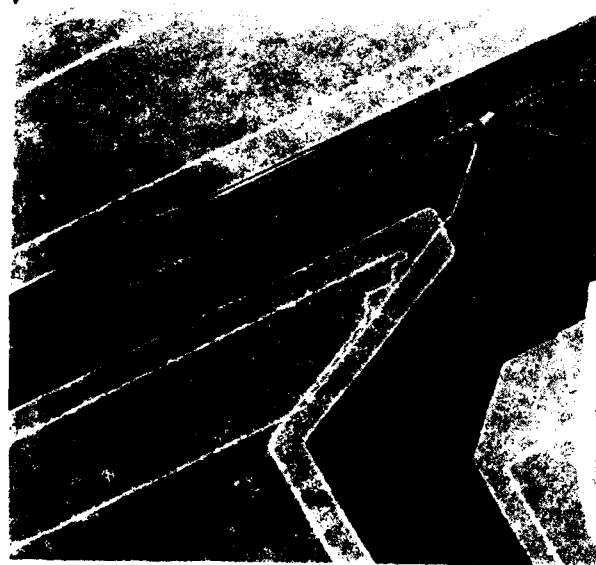
Figure A-18 Type N-32 #48 FET showing deterioration in the gate channel and adjacent ohmic contact metallizations. (a) 200X. (b) 1820X.

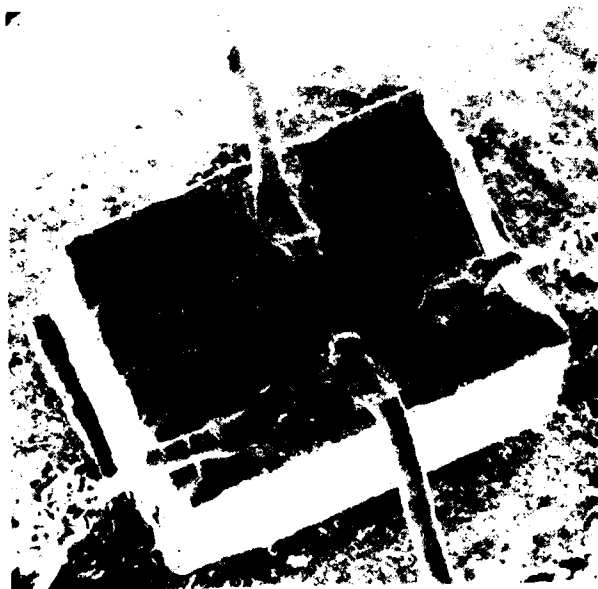
Figure A-19 (a) Type R-51 No. 10 FET showing corrosion of the source bond wires (130X); (b) Type R-51 No. 20 FET showing similar corrosion (150X). Note on the left that the bottom of the die is fractured.

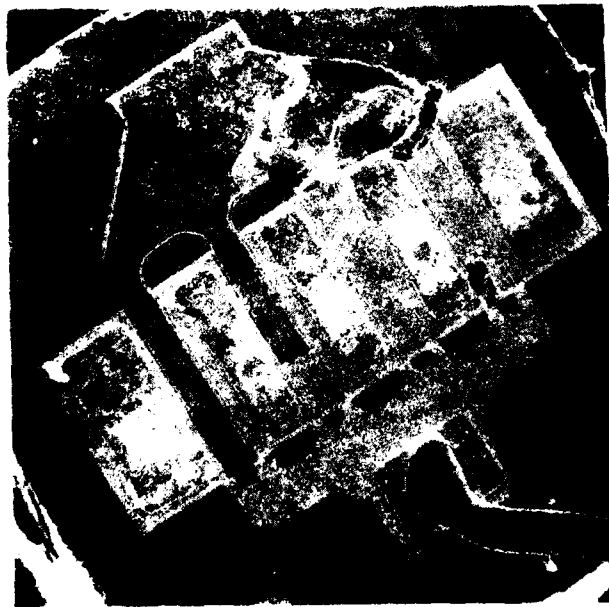
Figure A-22 Test A failures. (a) Type D-250/6 No. 51 FFT at 156X.
(b) Type M-400/6 No. 17J FET at 214X.

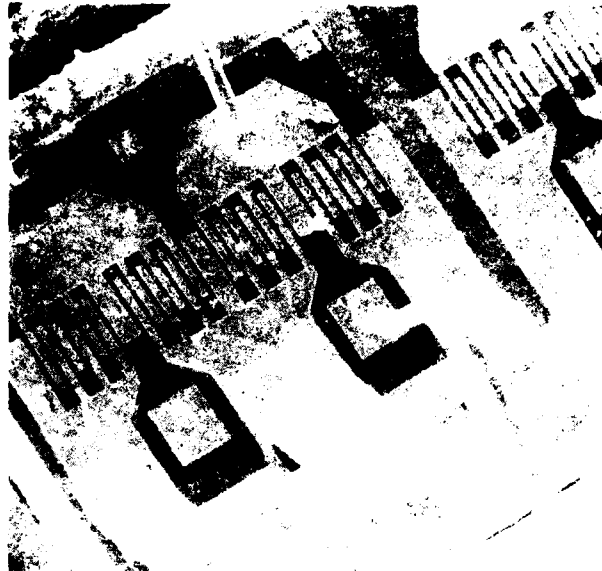
Figure A-23 Test A failure of Type
N-300/7 No. 2J FET.
(a) 100X. (b) 400X.

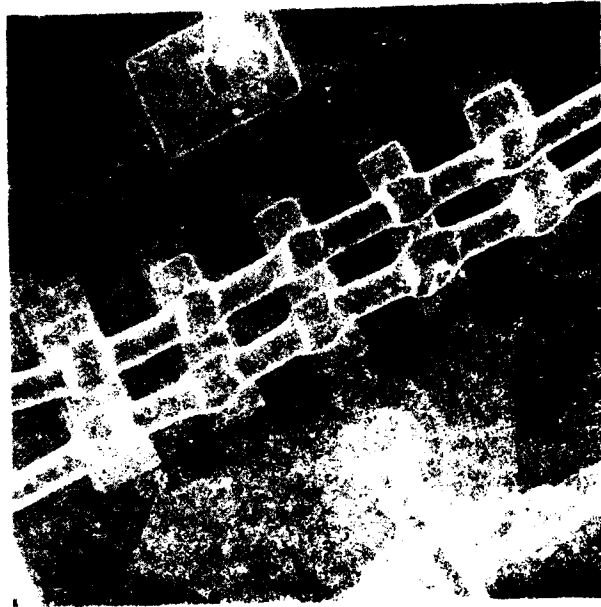
Figure A-27 Test D failure of Type T-LAB
No. 3 FET at 180X.

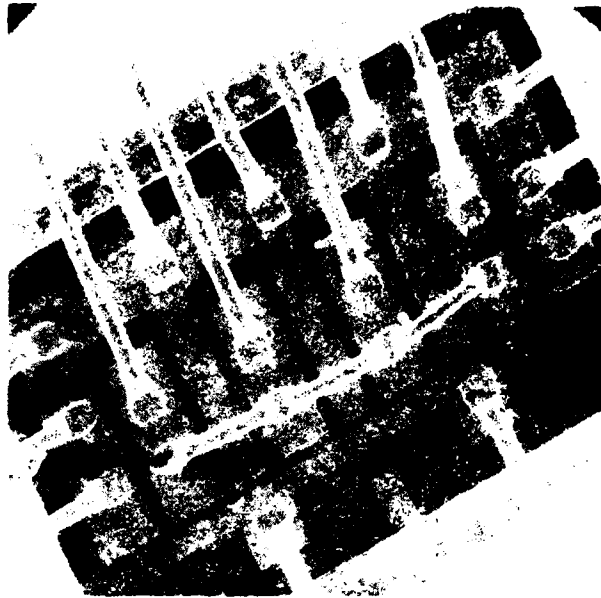
Figure A-29 Catastrophic failure of Type D-250/6 No. 41 FET at 228 hours of 200°C heatsink temperature, 8V drain bias, $P_{in} = 100$ mW. (a) 144X. (b) 2800X.
